I-515 Henderson Asphalt Rubber Overlay

Asphalt Rubber Overlay

Date: January 23, 2008
 To: A. Reed Gibby
 From: Dana M. Lodico, P.E.
 Subject: I-515 Pavement Overlay, OBSI Measurement

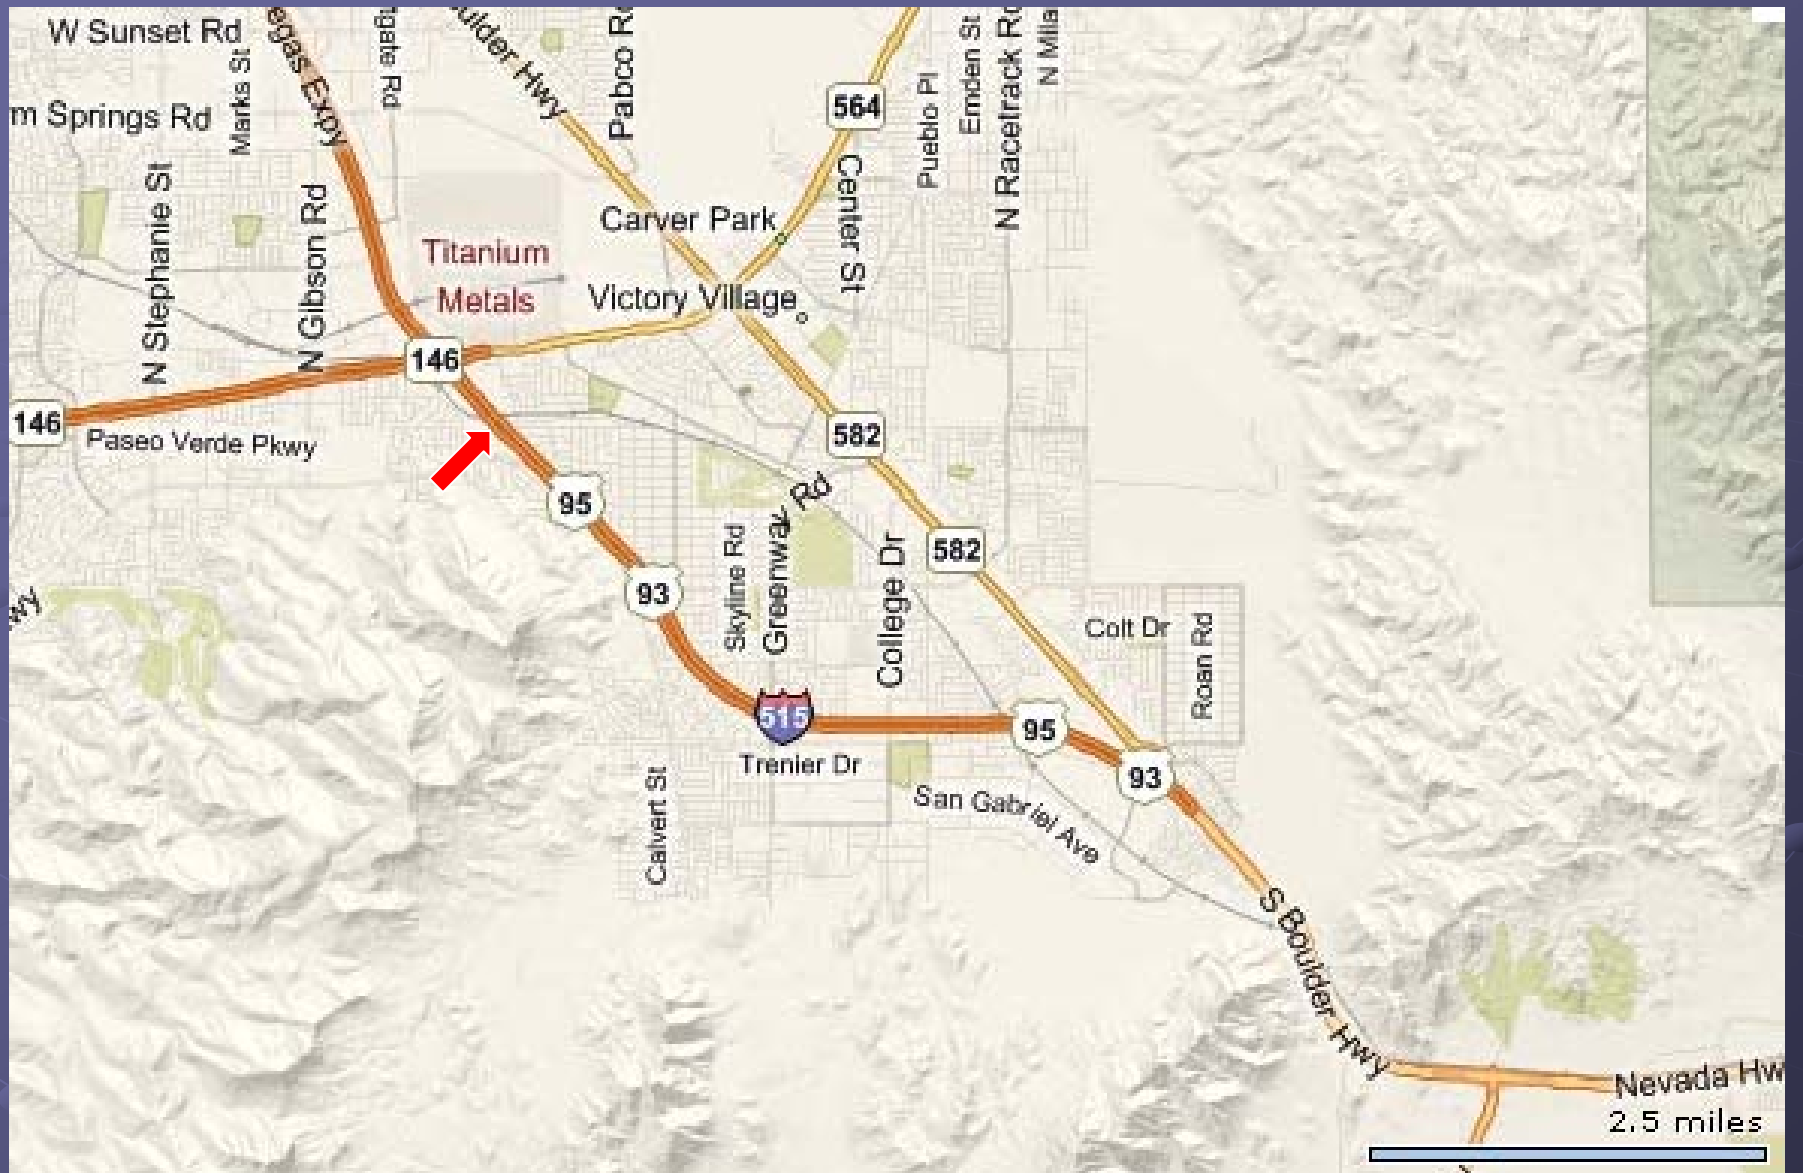
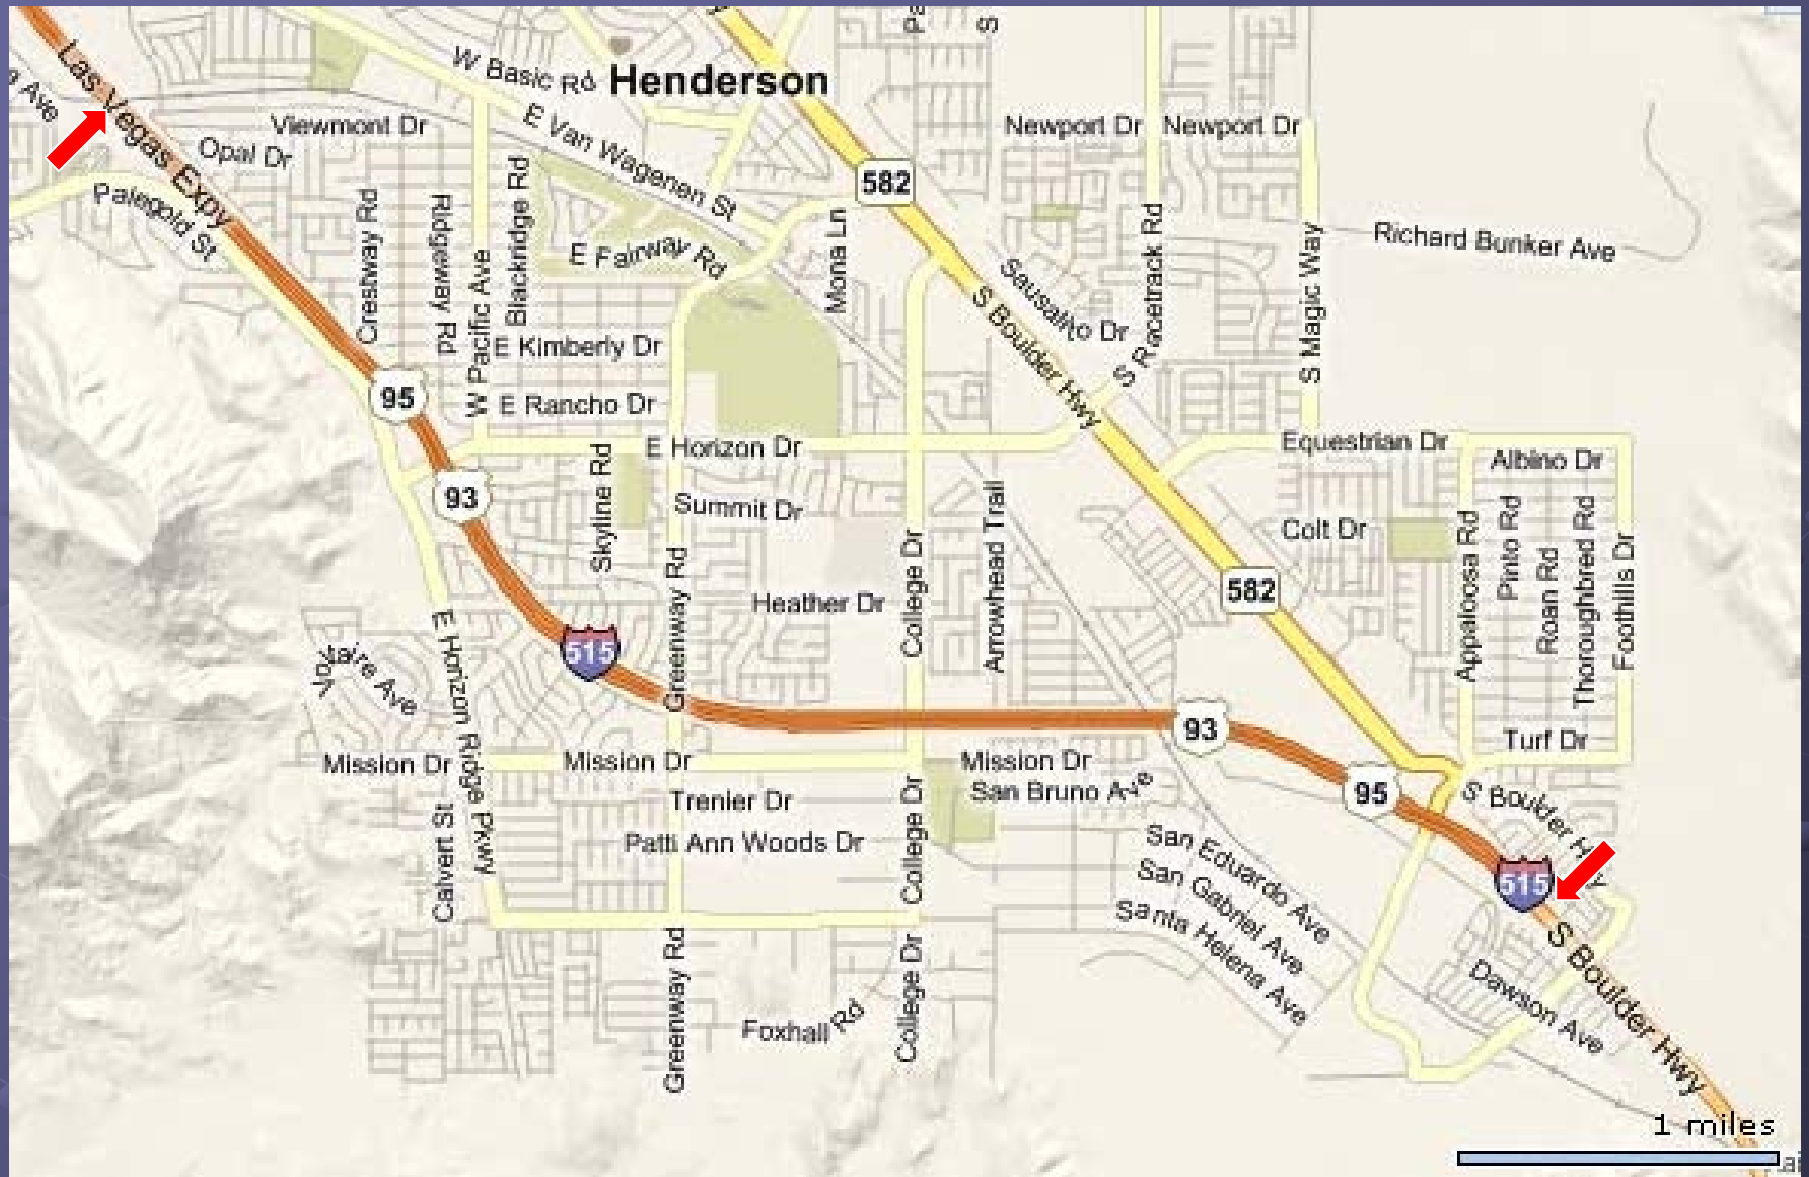
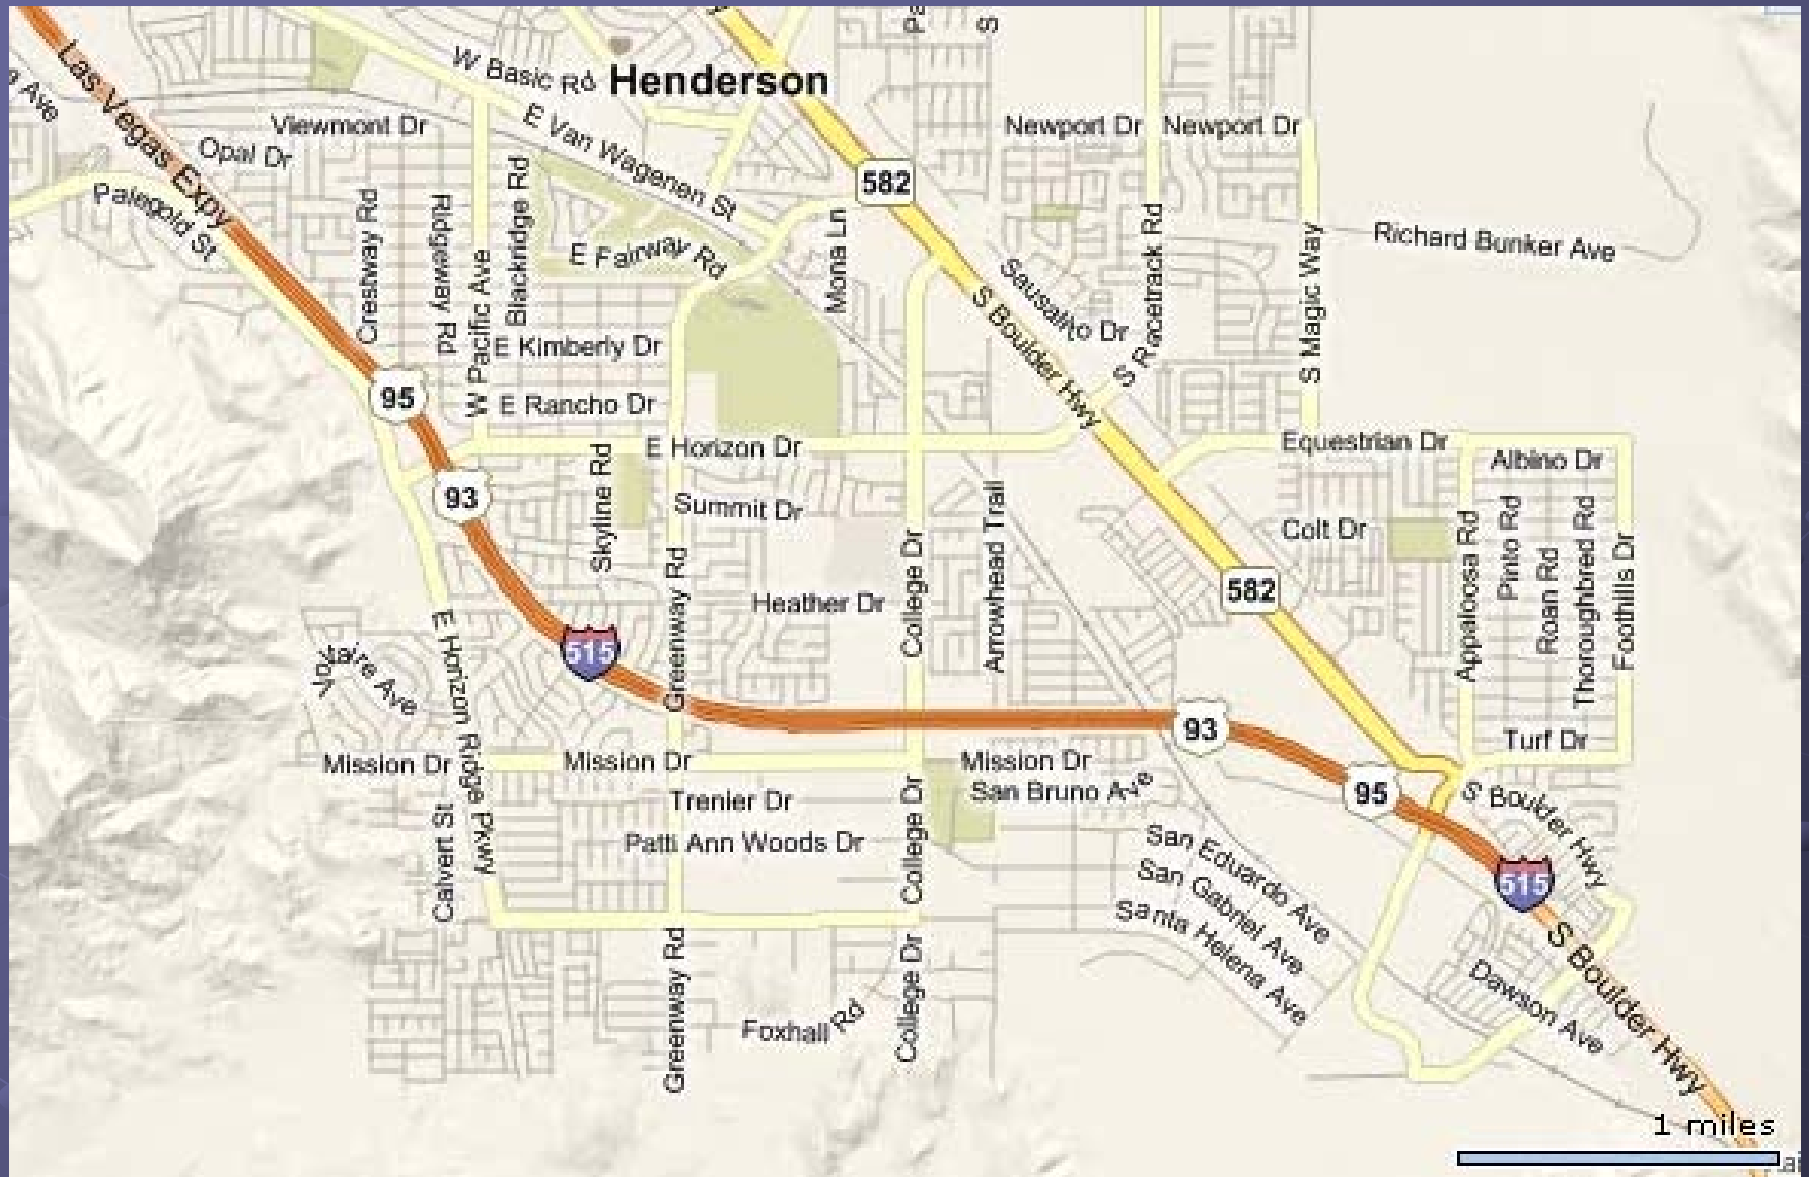
- Added to Contract 3322 as a test section.
- Also known as: Asphalt Rubber – Asphalt Concrete Friction Course (AR-ACFC) from Arizona DOT
- Placed on 6 miles of I-515 (US 93/95) from the southern end of Henderson to just south of the new interchange with the Beltway (I-215).

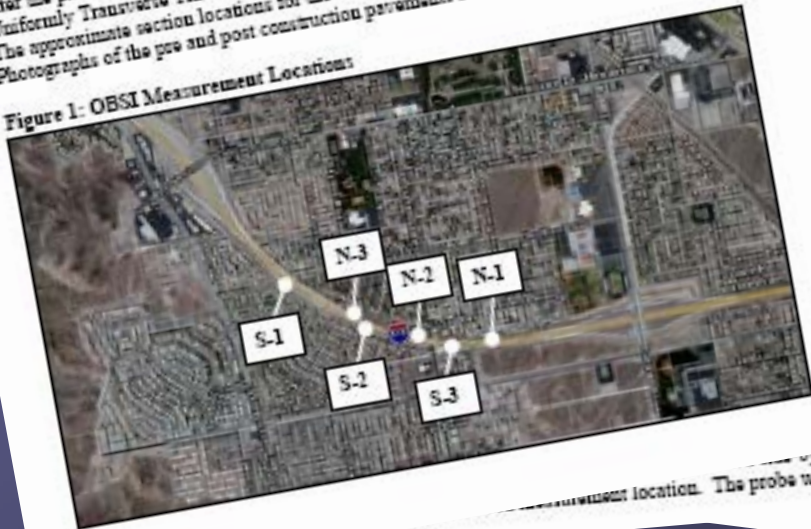
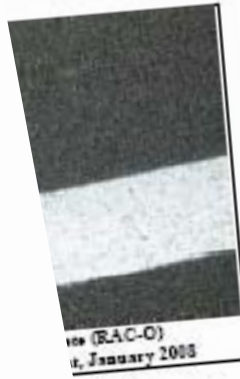
Figure 1: OBSI Measurement Locations

On Board Sound Intensity measurements were conducted on I-515 between the College Drive and West Horizon Drive Interchanges (Exits 57 and 59) on November 1, 2006 and January 21, 2008, prior to and after the placement of rubberized asphalt concrete (ROGFC). The pre-construction pavement was older Uniformly Transverse Tined PCC pavement. The post-construction pavement is Rubberized Asphalt. The approximate section locations for the 2006 and 2008 measurements are indicated in Figure 1. Photographs of the pre and post construction pavements are shown in Figure 2.

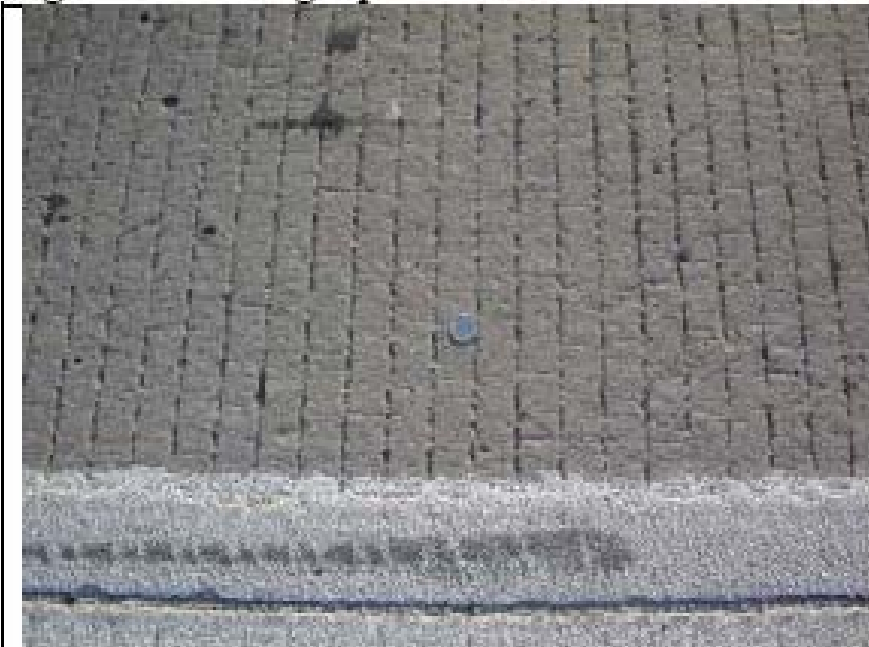
Figure 2: Photographs of Pavement Surfaces

**Uniformly Transverse Tined PCC (PCC)
Pre-Construction Pavement, November 2006**

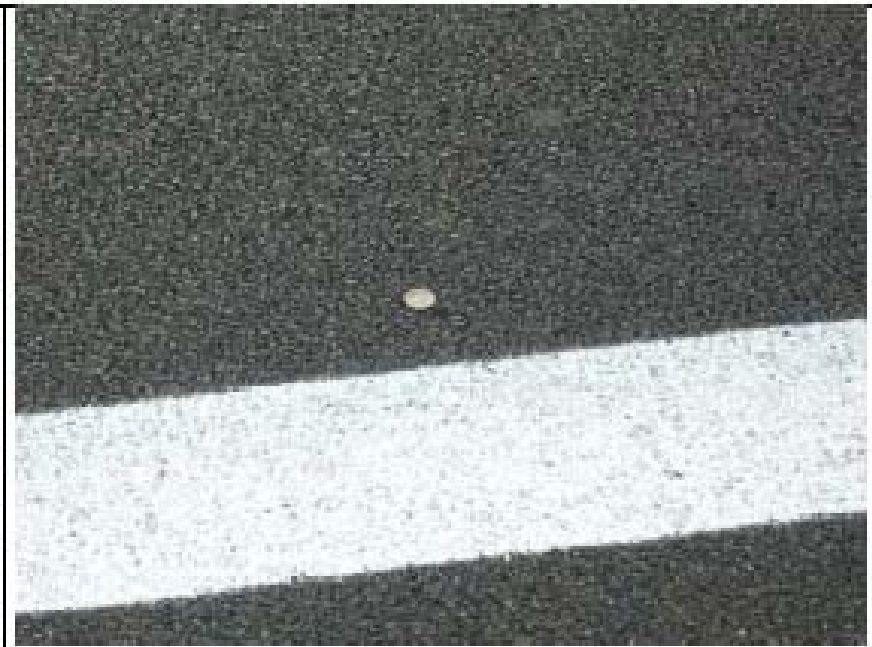
**Rubberized Asphalt Concrete (RAC-O)
Post-Construction Pavement, January 2008**

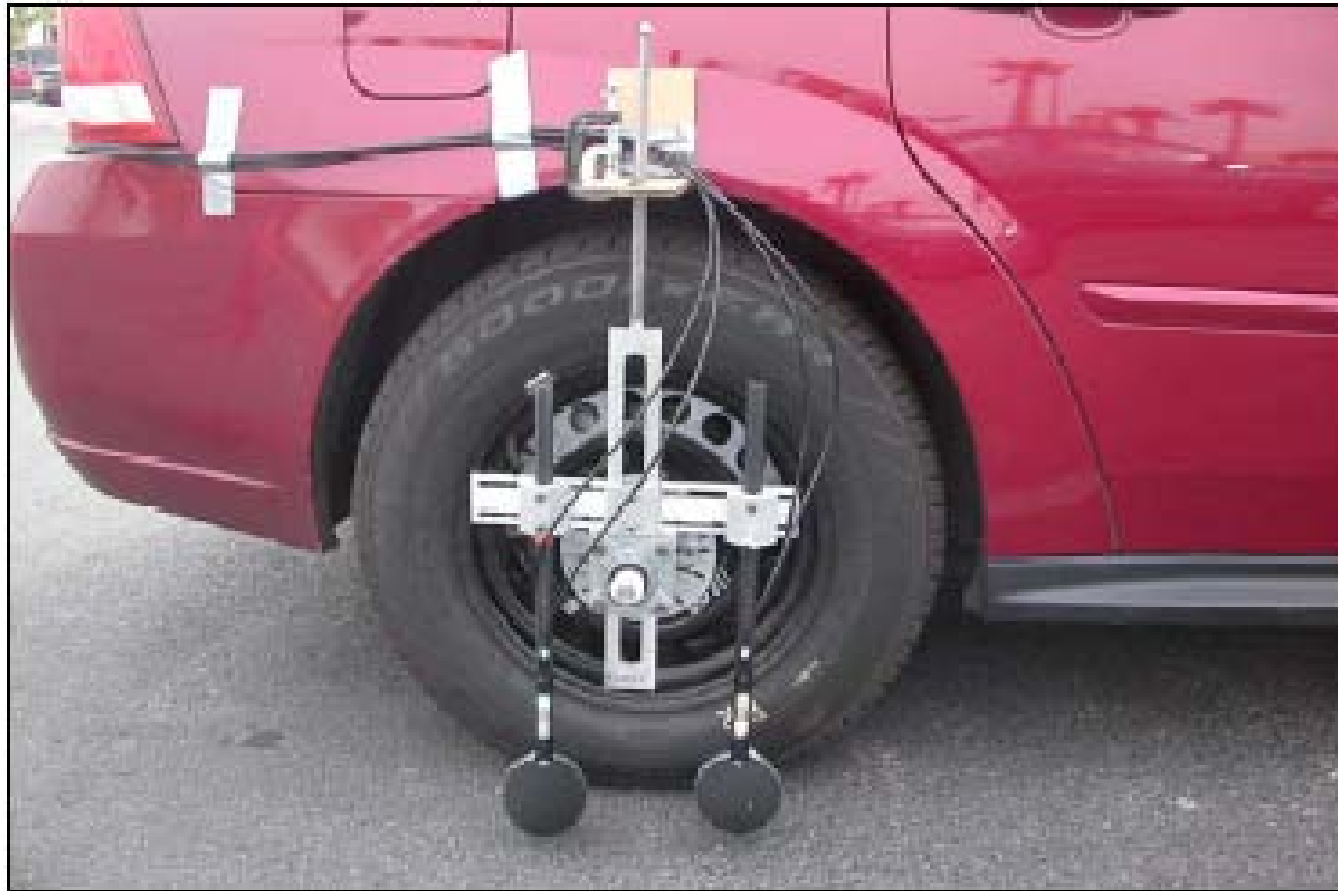
Figure 3: OBSI Equipment Installed on the Malibu Test Vehicle

test vehicle and the Aquatred 3 test tire travel lane at a test speed and southbound associated microphones that are very close to be measured

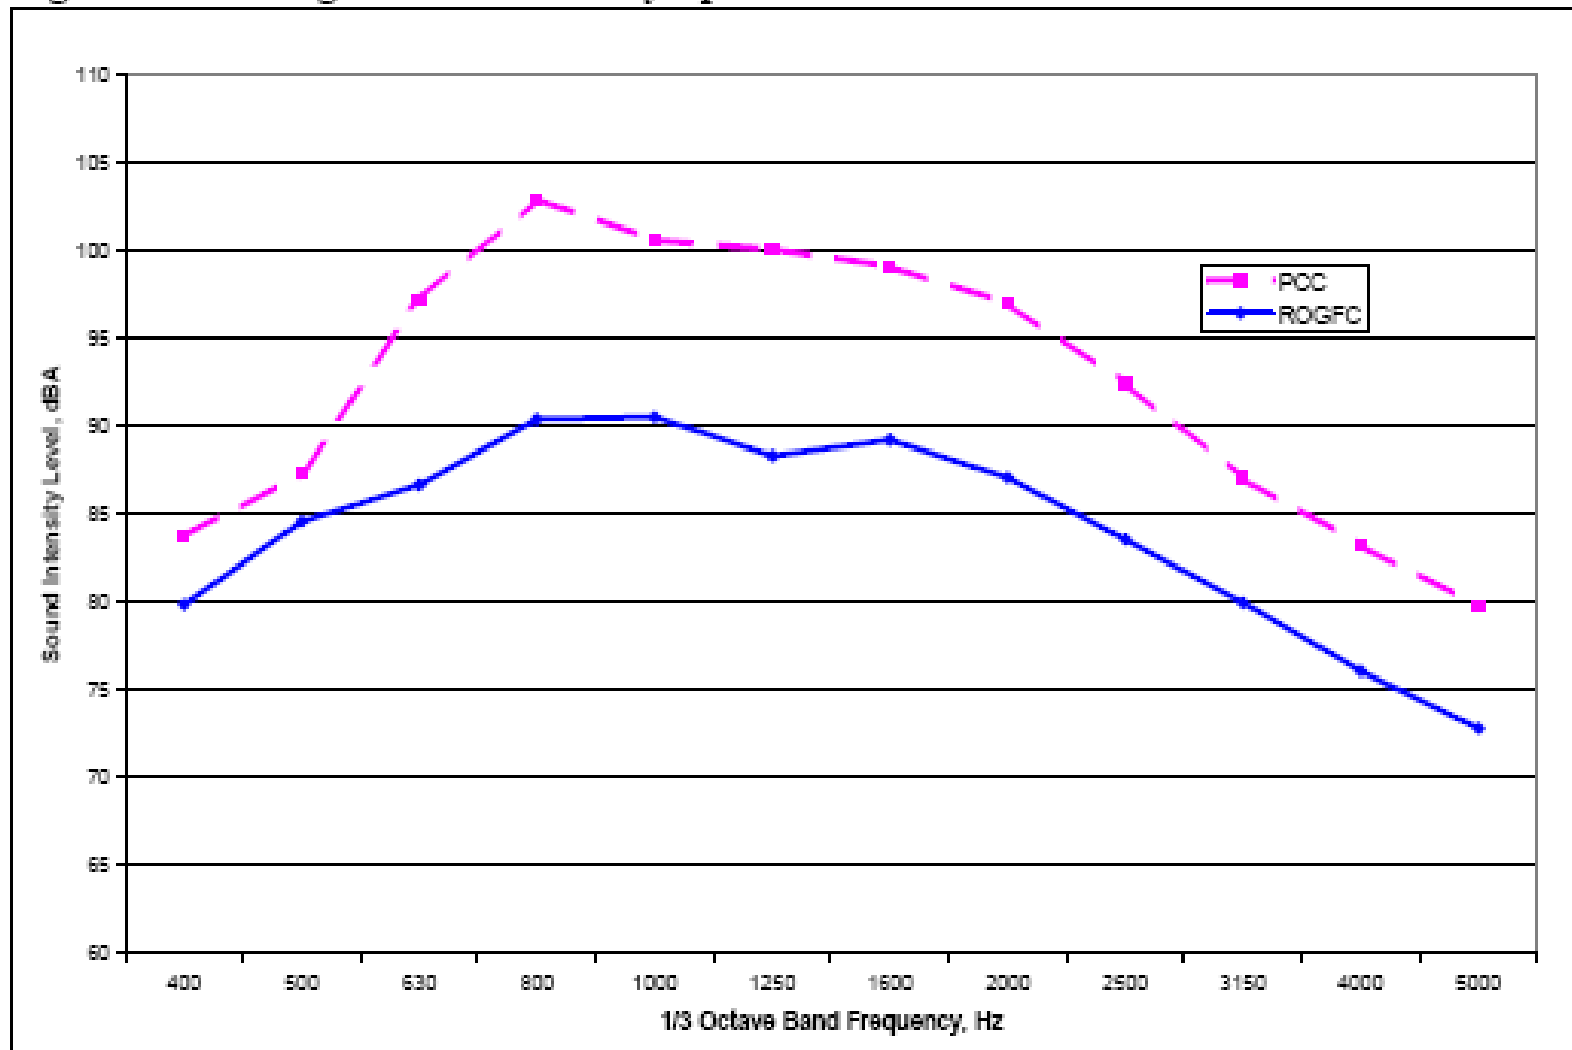
Figure 4: Average Sound Intensity Spectra for Pre and Post Construction Pavements

Reduction of 10.7 decibels!

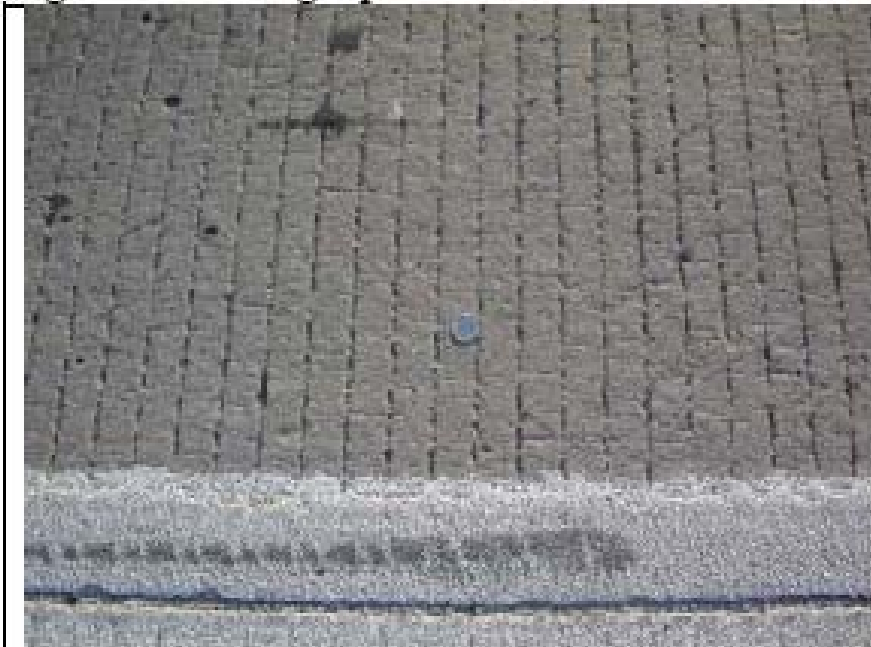
Figure 2: Photographs of Pavement Surfaces

**Uniformly Transverse Tined PCC (PCC)
Pre-Construction Pavement, November 2006**

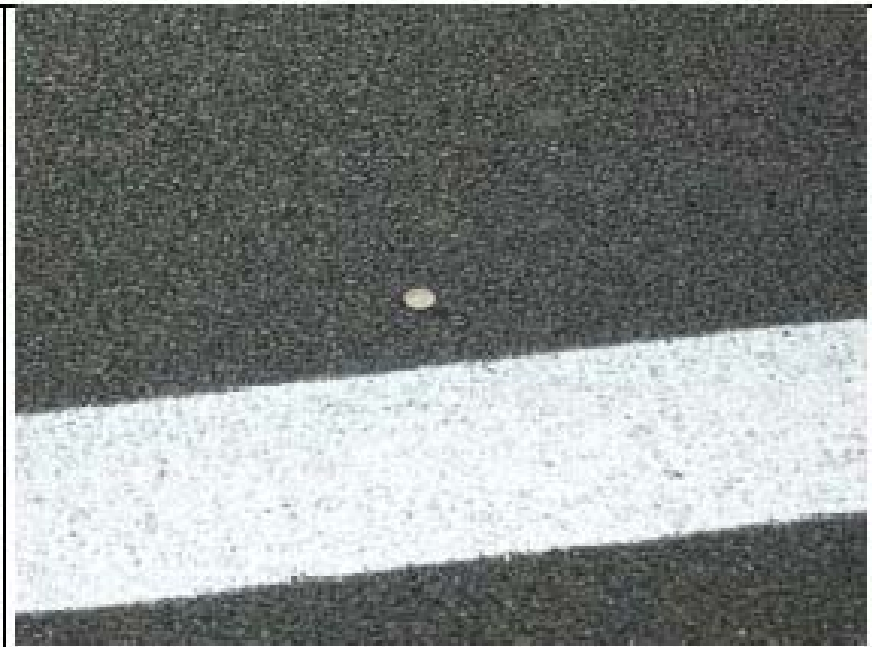
**Rubberized Asphalt Concrete (RAC-O)
Post-Construction Pavement, January 2008**
